Fire Resistance Tests on Wood and Composite Wood Beams

Venkatesh Kodur, PhD-PE, James Stein, and Rustin Fike, PhD Department of Civil and Environmental Engineering, Michigan State University

Mahmood Tabaddor, PhD Predictive Modeling and Risk Analysis Group, Corporate Research, UL

DECEMBER 2011

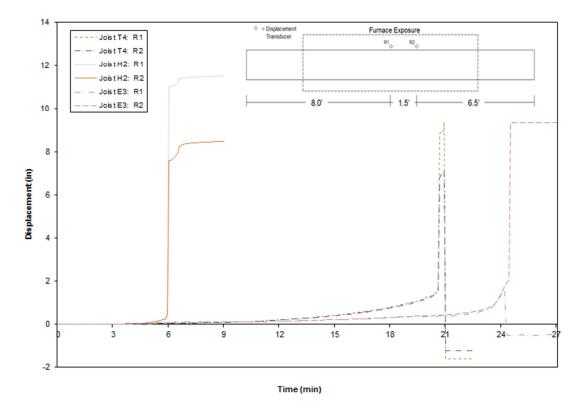
Figure 16: Measured representative vertical displacements during fire resistance tests on joists T4, H2, and E3

The measured vertical displacements during the fire resistance tests on joists T4, H2, and E3 are displayed in Figure 16 as a representation of typical vertical displacement values recorded through the fourteen fire resistance tests. The displacements recorded for joist T4 were typical of those recorded for the traditional joists (T1 to T4). Negligible displacements were recorded until 6 minutes into testing, at which point the displacements increased gradually to 1.5 inches by about 20 minutes. At this point, the joist failed and attained free-fall corresponding to the recorded displacements of 7 to 9 inches. The displacement plots for joist H2 characterize those recorded for the engineered lumber (E1, E2, C1, C2, H1, H2, and H3). From 4 to 6 minutes, the displacements increased gradually from 0 to 1.5 inches. At this point, the joist failed, achieving free-fall and displacements ranging from

7.5 to 11 inches. Joist E3, which had an intumescent coating, is also represented in Figure 16. At about 4 minutes, the displacements began to increase gradually, and by 24 minutes they reached about 2 inches. At this point, the joist failed, reaching free-fall and displacements as high as 9.5 inches were recorded. Based on UL's Report on Structural Stability of Engineered Lumber in Fire Conditions [4], deflection and deflection rate limits from ISO 834:1 were consulted to define structural failure. It was found that these criteria did not apply to these tests because these limits described failure times after the joists had already clearly ruptured.

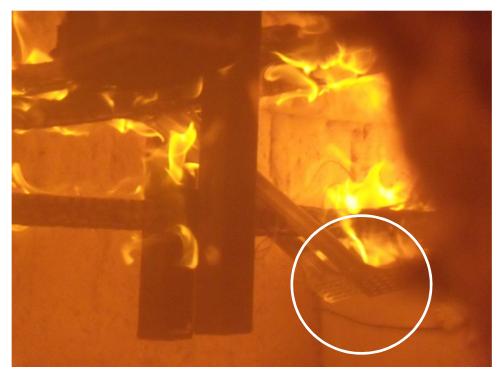
Figure 17: Connection failure of hybrid joist H2

Observations made when testing the hybrid joists H1 and H2 were used to determine the failure mode of these joists. It was concluded that the failure mode for the hybrid joists was the failure of the steel/wood connections on the bottom cord. It was observed that these connections failed, and because they were no longer connected to the bottom cord, the steel members' capacity was reduced to zero. Without support from the steel members, the top cord failed under the applied load. Coinciding with these failures, the ends of some steel members hung freely below the joist, identifying the steel/wood connection on the bottom cord as the source of failure. The photograph in Figure 17 depicts this type of failure on joist H2. Similar to the other types of engineered joists, this failure process occurred quickly and suddenly relative to the traditional joists. Further testing and analysis is required to determine the mechanism and progression of failure in these connections. It should also be noted that in these tests, much of the plywood web at the ends of the joists were not exposed to fire conditions.

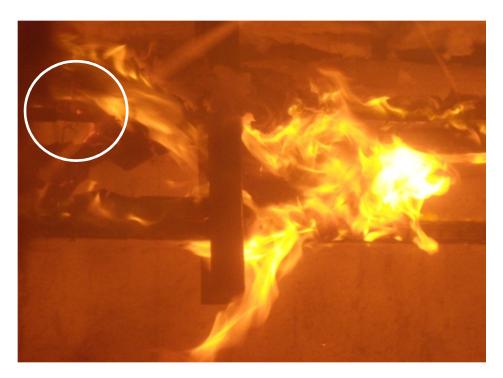
Figure 18: Formation and enlargement of voids in web of joist C2

The test data and observations from tests on joists E1, E2, C1, and C2 can be used to determine the failure mode of engineered I-joists and castellated I-joists. They indicate that the cause of failure was the burning through of the web. As one of these beams ignited and burned, voids in the web appeared and the cut-outs enlarged as depicted in Figure 18 for joist C2. Eventually, the integrity of

the web was reduced enough for the joist to fail. This failure process occurred quickly and suddenly relative to the traditional joists.

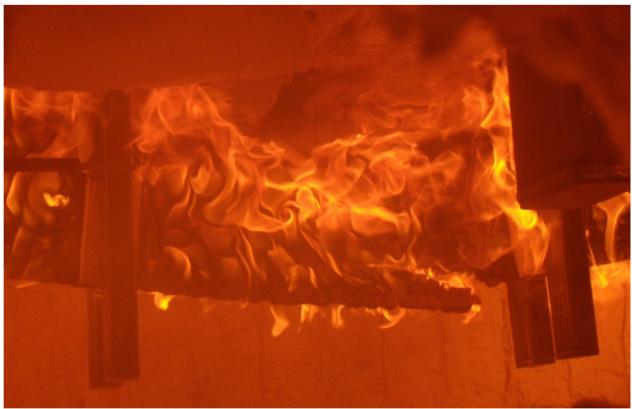
Figure B-7: Traditional joist (T4) immediately after failure

The failure mode of traditional joists was evaluated by analyzing test data and recorded observations during tests on joists T1 to T4. It was determined that the failure of these joists was caused by reduction in cross-section. In this process, the exposed surfaces of a traditional joist ignited and burned. As the joist burned, the cross-section gradually burned away corresponding to a gradual loss of stiffness and strength of the joist. Eventually, the cross-section, stiffness, and strength were reduced to the point that the joist could no longer support the applied load, leading to rupture of the joist. Also, the average internal temperatures in joists T3 and T4 were elevated at the time of failure when compared to other joist types. This may be due to the reduction in cross-section. It could also be attributed to the joist experiencing fire conditions (elevated temperatures) for an extended time period, when compared to other joist types, due to the higher failure time of traditional joists. For repeatability purposes, joist T5 was tested under 70% of its design load (similar to joists T1 and T2) with sheathing attached to its top surface (similar to joists T3 and T4). As expected, the data obtained was very similar to data collected from joists T3 and T4.
