# Fire Service Collapse Hazard Floor Furnace Experiments

January 2012

## Executive Summary

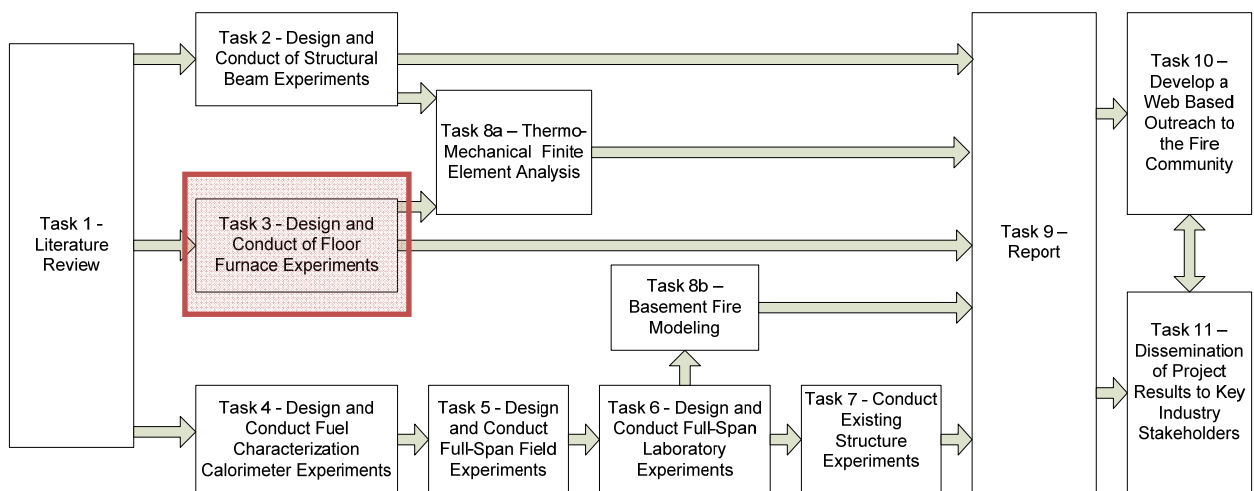
**Figure 1. Project Flow Chart**

The technical plan for this grant project is shown in Figure 1. The task covered in this report is highlighted in red. For results from other tasks or to see the summary report that integrates the results of all of the tasks visit [www.ul.com/fireservice](http://www.ul.com/fireservice).

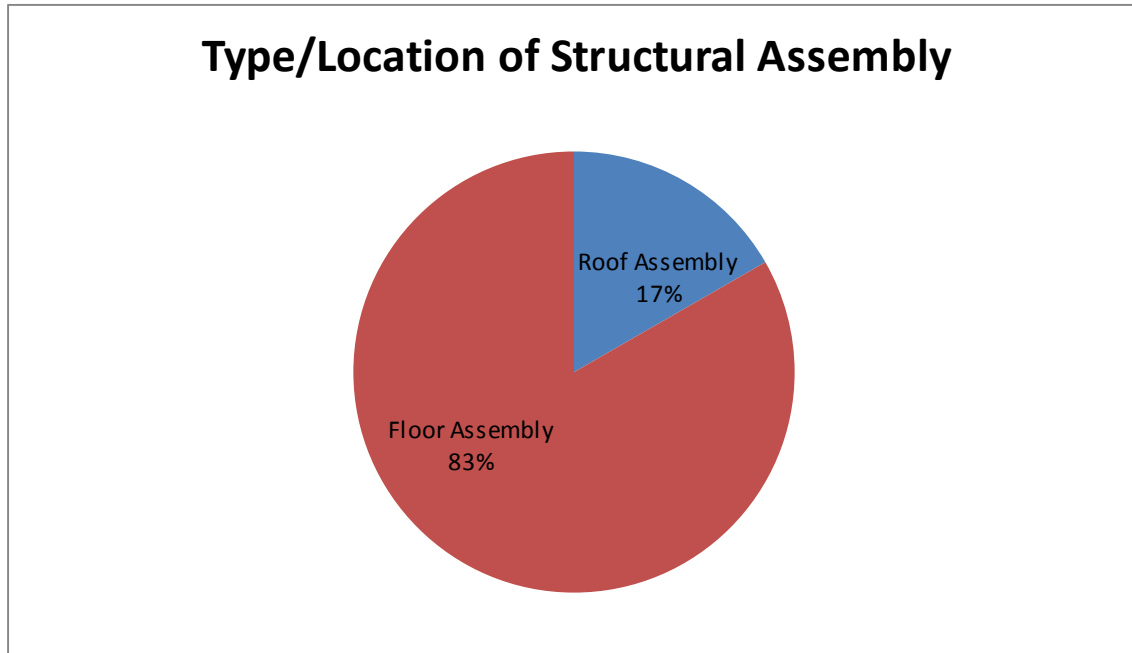
**Figure 2. Structural Assembly Analysis of NIOSH Firefighter Fatality Investigations**

Generally the majority of the NIOSH Firefighter Fatality Investigations addressing structural collapse determine the fires ability to weaken or compromise areas within the occupancy that are not protected by active or passive fire protection methods. This fact highlights two distinct areas within frame or ordinary constructed buildings where a fire has the ability to burn and weaken exposed structural elements, i.e. the attic area under the roof assembly or the basement area under the first floor assembly. Figure 2 defines the percentage of fire events with respect to floor or roof assemblies.

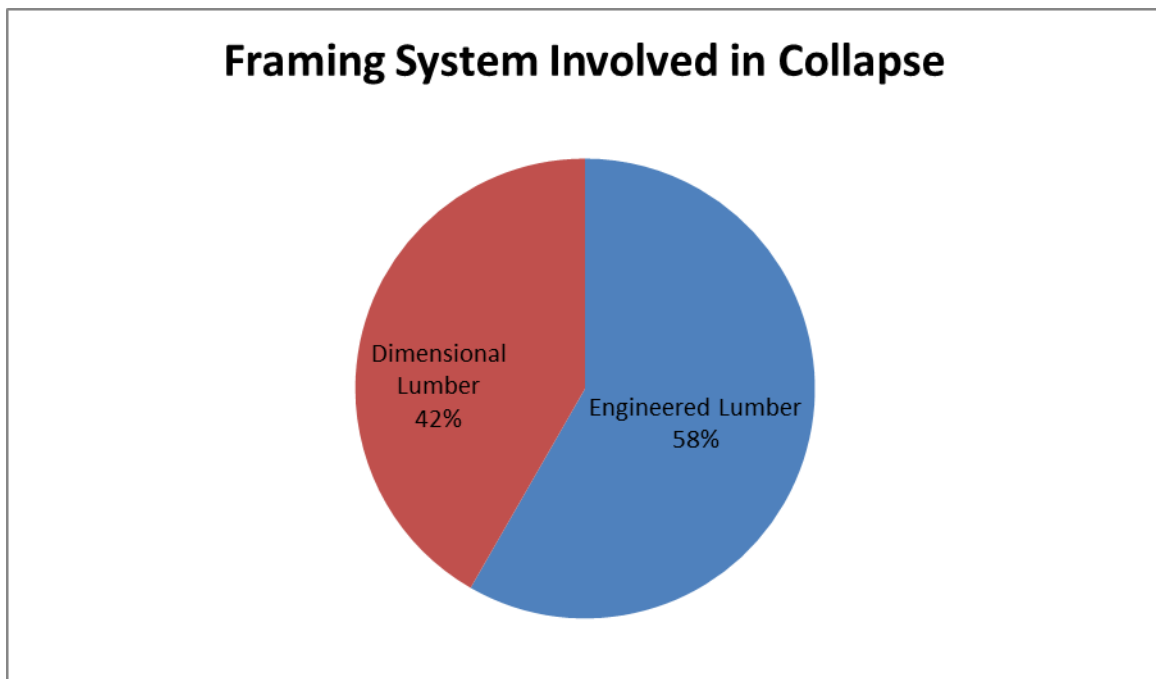
**Figure 3. Framing System Analysis of NIOSH Firefighter Fatality Investigations**

Fires within these distinct areas then burn and weaken the structural elements surrounding the involved fire area. Figure 3 defines the percentage of fire events with respect to framing systems that collapsed during fire ground operations.

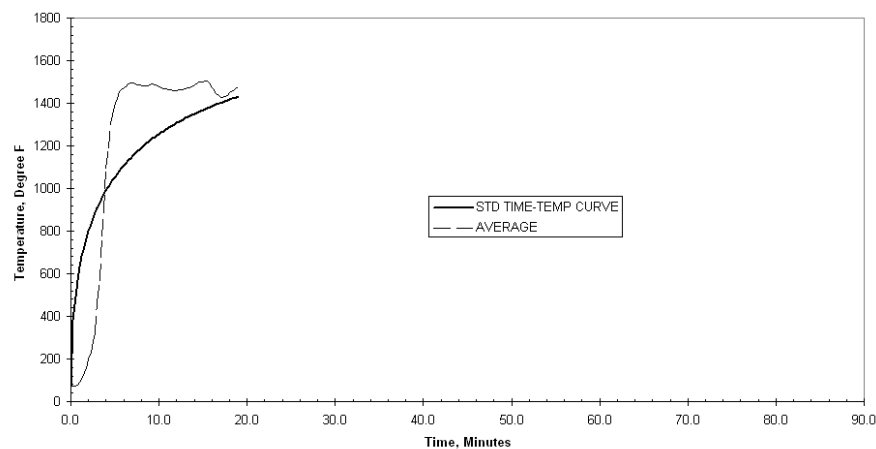
**Figure 4 - UL263 Standard Time Temperature Curve and Average Furnace Temperature vs. Time for Assembly No. 1**

- Unprotected wood assemblies, both dimensional and engineered components, upon combustion contributed significant fuel loads to the experimental fires raising corresponding temperatures above the standardized ASTM E119 time temperature curve.

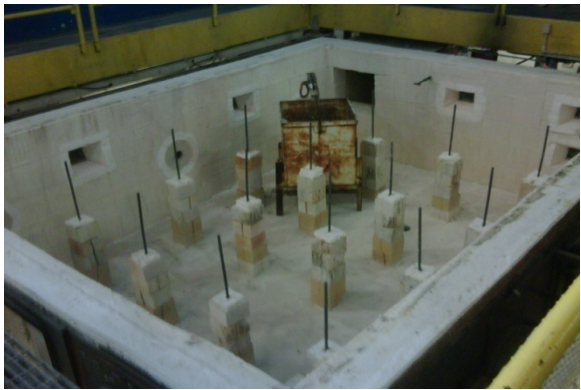
**Figure 5. UL Floor furnace**

The floor furnace at UL's laboratory in Northbrook, IL was utilized to conduct the experiments (Figure 5). The floor furnace exposes a 14 ft. by 17 ft. floor system to the standard time temperature curve (Table 11). The standard states the transmission of heat through the specimen during the classification period shall not have raised the average temperature on its unexposed surface to more than 250°F above its initial temperature or raised any one point on its unexposed surface more than 325°F. This criterion was measured however the test was conducted until the floor system collapsed into the furnace before termination and suppression.

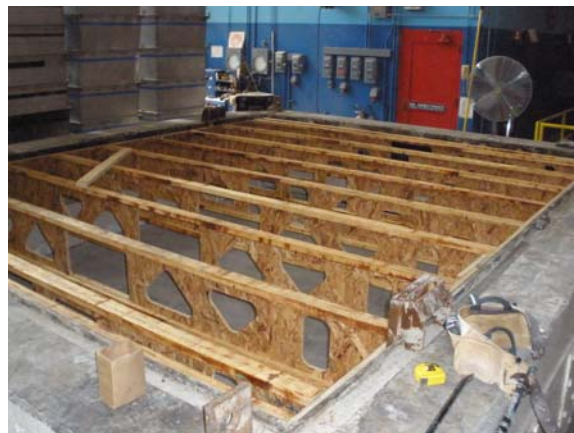
**Figure 6 - Engineered Castellated I Joist**

**Engineered I Joists with Openings** – The nominal 16 in. engineered I Joist measured 16 in. tall and were cut to a length of 13 ft. 7-3/4 in. The chords consisted of 3-1/2 in. wide by 1-3/8 in. deep solid lumber with multiple sections finger jointed and glued together to make the full lengths. The web consisted of 5/8 in. thick oriented strand board and was provided with 6 openings of various sizes. The average weight of the I Joists was 63.43 lb. (Figure 6).

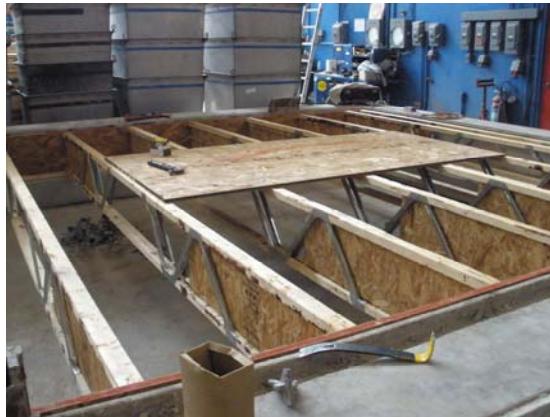
**Figure 7 - Engineered Wood and Metal Hybrid Trusses**

**Engineered Wood and Metal Hybrid Trusses**– The nominal 14 in. deep engineered trusses measured 14 in tall and were cut to a length of 13 ft. 8 in. The top and bottom chords consisted of 2-1/2 in. wide by 1-1/2 in. deep solid lumber with multiple sections finger jointed and glued together to make the full lengths. The web consisted of metal gusseted U shaped steel web members measuring 0.04 in. thick with 0.34 in. long teeth projecting perpendicular to the plane of the web member. The triangular shaped steel web members were located on both sides of the top and bottom wood chords and measured 14 in. tall by 29 in. long. At the end of the trusses, the trimmable ends consisted of the top and bottom chords with 1/2 in. thick oriented strand board webbing. The average weight of the trusses was 42.04 lb. (Figure 7).

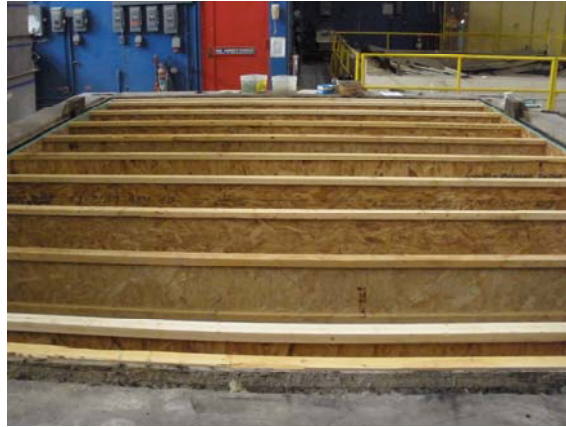
**Figure 8 - Engineered Wood I Joists**

**Engineered I- Joists** – The nominal 12 in. engineered I Joists measured 11-7/8 in. tall and were cut to a length of 13 ft. 8 in. The chords consisted of 2-1/2 in. wide by 1-1/2 in. deep solid lumber with multiple sections finger jointed and glued together to make the full lengths. The web consisted of 3/8 in. thick oriented strand board. The average weight of the I Joists was 38.4 lb. (Figure 8).

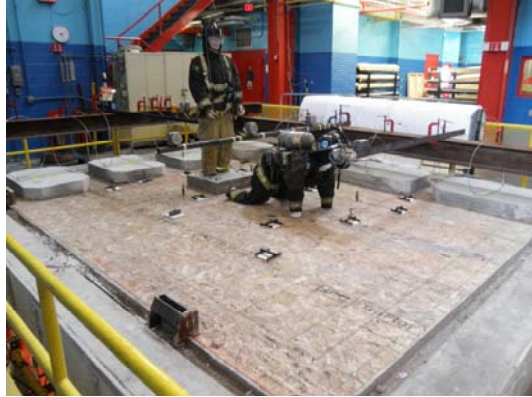
**Figure 9 - Loading of Assemblies 1, 2, 3 and 5**

Two different load configurations were utilized during this experimental series. Assemblies 1, 2, 3 and 5 were loaded with a uniform load of 40 lb/ft<sup>2</sup> applied to the South and West edges of the assembly. The assembly was divided into quarters by length and width and the loading was positioned over the Western and Southern quarters of the assembly. In addition to the uniform load, two 300 lb. mannequins were located 24 inches North and South of the East-West centerline of the assembly, at the center of the span. One mannequin was intended to simulate a standing firefighter and the load was distributed over a square foot base. The other mannequin was intended to simulate a crawling firefighter and the load was distributed through the hands and knees (Figure 9). Drawings showing the floor assembly loading are located in Appendix A.

For Assemblies 1, 2, 3 and 5, the load placed on the samples was intended to represent a conservative residential loading condition. A load of 40 lb/ft<sup>2</sup> was placed along two of the four edges of the floor assemblies to represent loads around a perimeter of a room, such as furniture. On each sample, two 300 pound concentrated loads were placed near the center of the sample. A mannequin, intended to simulate fire service personnel, represented each concentrated load.

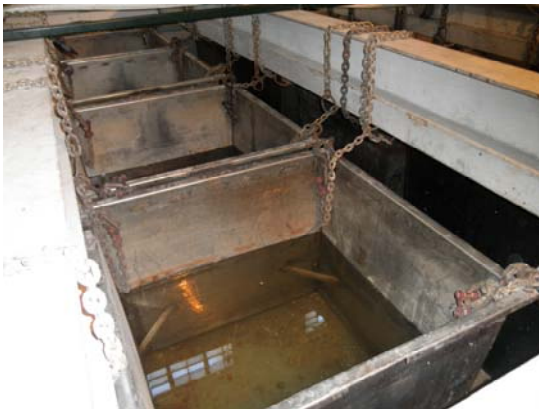
**Figure 10 - Steel Tanks Filled with Water**

Assembly 4, 6 and 7 were loaded to 100% of the design load of the engineered I Joists and solid lumber. Sixteen steel tanks were filled with water and distributed evenly over the entire unexposed surface of the assembly (Figure 10 and Figure 11). Drawings showing the floor assembly loading are also located in Appendix A.

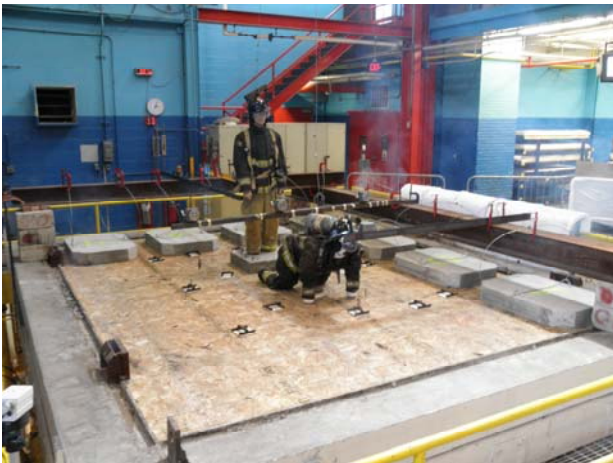
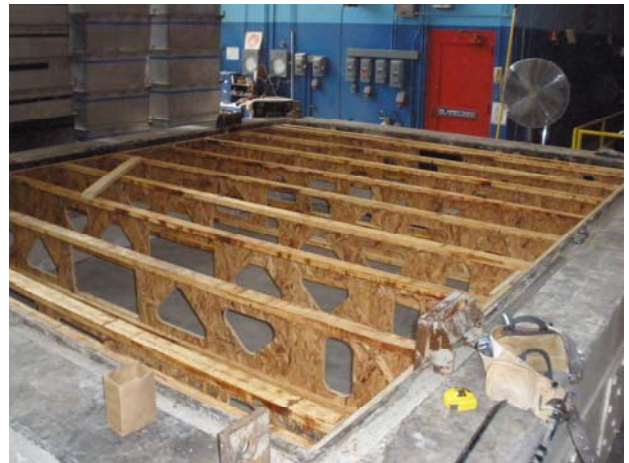
Experiment 1 examined an engineered I-joist floor assembly with openings with the modified loading configuration (Figure 13 and Figure 14). The floor assembly failed at 8:10 after ignition. Observations made during the experiment of the exposed and unexposed sides of the floor assembly are detailed in Table 13. The average furnace temperature during the experiment began below the standard time temperature curve but exceeded it at approximately 2 minutes, when the floor system ignited and the temperatures remained above the curve for the duration of the experiment (Figure 15). The furnace pressure and oxygen concentration measured in the furnace are presented in Figure 16 and Figure 17 respectively. The pressure remained between -0.2 in.w.c. and 0.6 in.w.c. throughout the experiment. The oxygen concentration decreased to less than 2 % by 2 minutes and remained at or below that concentration until collapse. Pressure and oxygen concentrations are not specified in the standard test method.

Figure 13. Pre-test un-exposed side

Figure 14. Pre-test joist layout

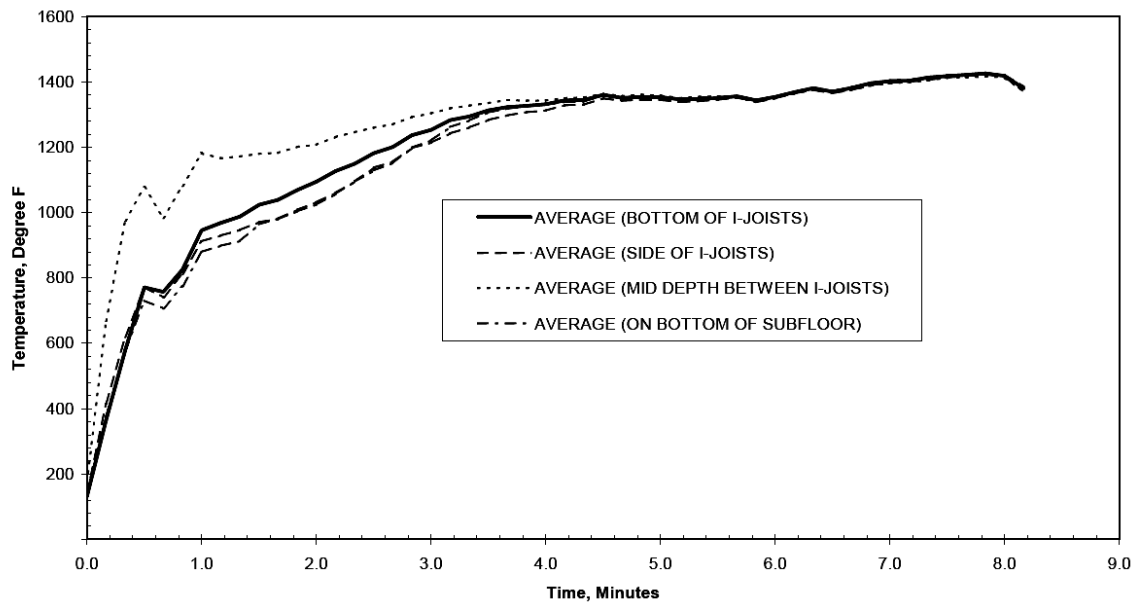
Figure 18 - Plot of Exposed Surface Temperatures vs. Time for Assembly No. 1

The average temperatures recorded on and around the floor assembly are shown in Figure 18. The average and maximum temperatures of the bottom chords of the I Joists just before the moment of collapse (8 min 0 sec) were 1419°F and 1443°F respectively. The

maximum individual temperature was recorded by thermocouple number 22. The average and maximum temperatures of the sides of the I Joists just before the moment of collapse (8 min 0 sec) were 1422°F and 1464°F respectively. The maximum individual temperature was recorded by thermocouple number 32. The average and maximum temperatures of the mid depth between the I Joists just before the moment of collapse (8 min 0 sec) were 1414°F and 1434°F respectively. The maximum individual temperature was recorded by thermocouple number 44. The average and maximum temperatures of the sub floor between the I Joists just before the moment of collapse (8 min 0 sec) were 1418°F and 1437°F respectively. The maximum individual temperature was recorded by thermocouple number 47. The average and maximum temperatures of the unexposed surface just before the moment of collapse (8 min 0 sec) were 164°F and 205°F respectively. The maximum individual temperature was recorded by thermocouple number 9. The average temperature and maximum temperatures were plotted on Figure 19.

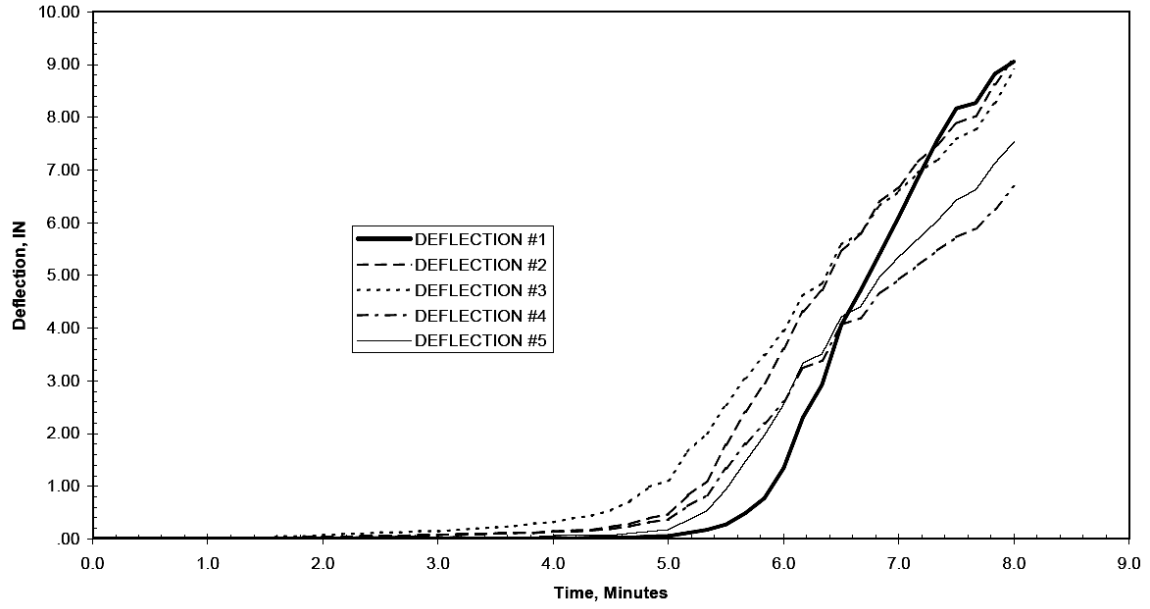
Figure 20 - Plot of Deflections vs. Time for Assembly No. 1

The deflection of the floor-ceiling assembly during the fire experiment is shown on Figure 20. The location of each deflection transducer can be seen in Appendix A. Measurable deflection began at approximately 2 minutes. A consistent deflection of approximately 3 in/min began at 5 minutes and continued until collapse. After the collapse of the floor system the fire was suppressed utilizing sprinklers mounted around the assembly and manual hose streams. Once the fire was suppressed, pictures were taken to document the condition of the floor system on the exposed and unexposed sides (Figure 21 through Figure 24). The failure mode for the engineered I-joists was due to burn-out of the web members.

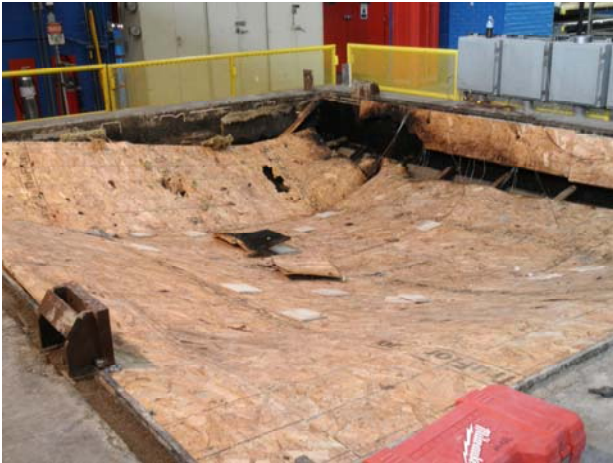
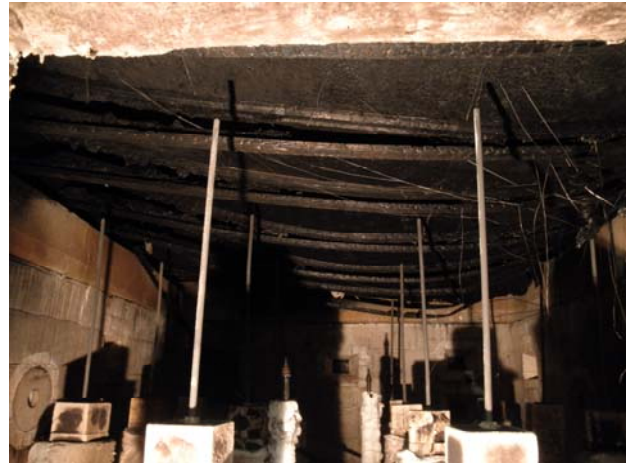
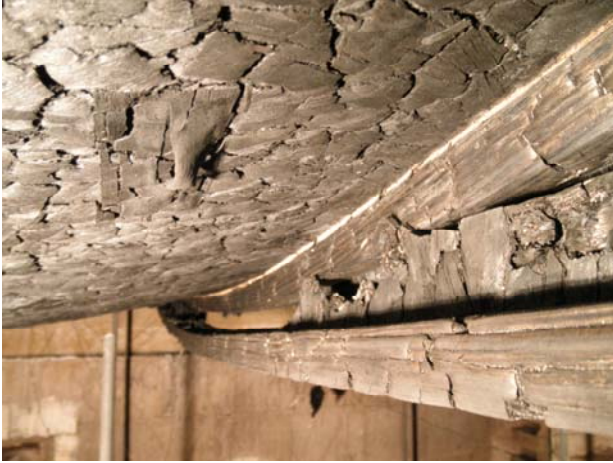
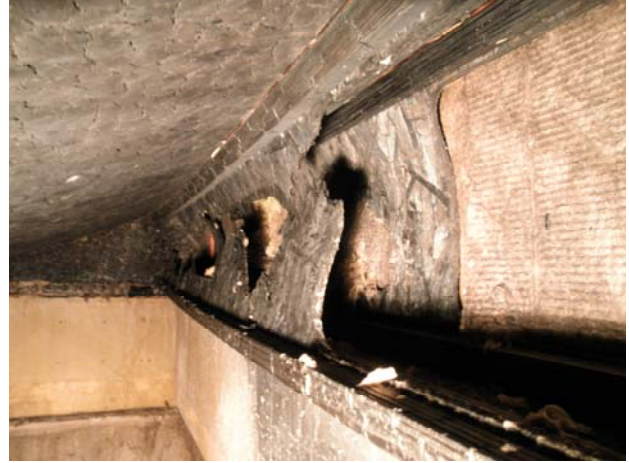
Figure 21. Unexposed side after removing load

Figure 22. Exposed side from North end

Figure 23. Joist with web burned away

Figure 24. Corner of furnace with some web remaining

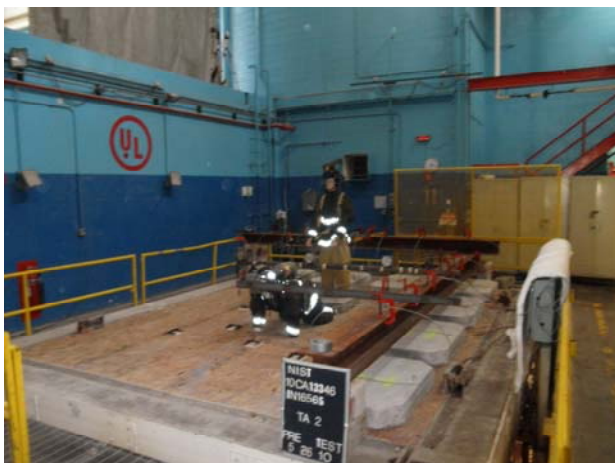
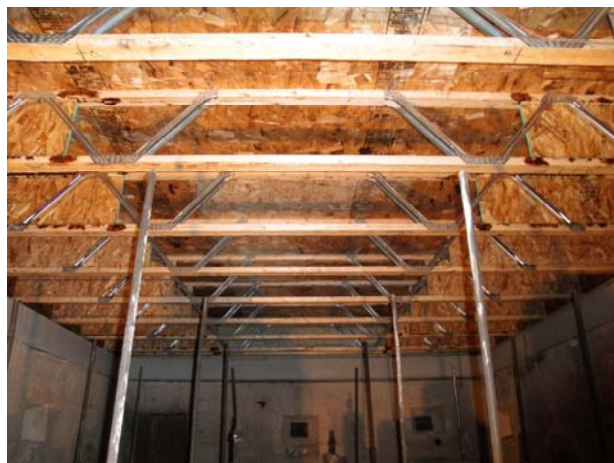
Experiment 2 examined an engineered wood and metal hybrid trusses floor assembly with the modified loading configuration (Figure 25 and Figure 26). The floor assembly failed at 5:30 after ignition. Observations made during the experiment of the exposed and unexposed sides of the floor assembly are detailed in Table 14. The average furnace temperature during the experiment began below the standard time temperature curve but exceeded it at approximately 2 minutes, when the floor system ignited and the temperatures remained above the curve for the duration of the experiment (Figure 27). The furnace pressure and oxygen concentration measured in the furnace are presented in Figure 28 and Figure 29 respectively. The pressure remained between -0.1 in.w.c. and 0.6 in.w.c. throughout the experiment. The oxygen concentration decreased to less than 2 % by 2.5 minutes and remained at or below that concentration until collapse.

Figure 25. Pre-test un-exposed side

Figure 26. Pre-test exposed side

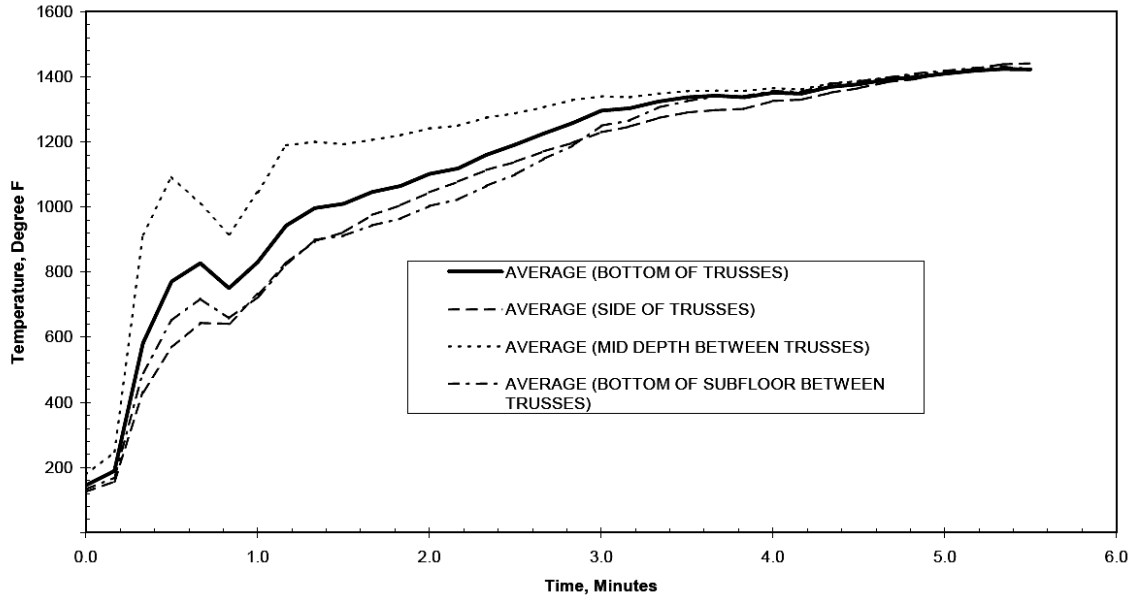
Figure 30 - Plot of Exposed Surface Temperatures vs. Time for Assembly No. 2

The average temperatures recorded on and around the floor assembly are shown in Figure 30. The average and maximum temperatures of bottom chord of the I Joists just before the moment of collapse (5 min 20 sec) were 1424°F and 1463°F respectively. The individual temperature was recorded by thermocouple number 25. The average and maximum temperatures of the sides of the wood joists just before the moment of collapse (5 min 20 sec) were 1438°F and 1489°F respectively. The individual temperature was recorded by thermocouple number 35. The average and maximum temperatures of the mid depth between the wood joists just before the moment of collapse (5 min 20 sec) were 1425°F and 1468°F respectively. The individual temperature was recorded by thermocouple number 43. The average and maximum temperatures of the sub floor between the wood joists just before the moment of collapse (5 min 20 sec) were 1431°F and 1478°F respectively. The individual temperature was recorded by thermocouple number 53. The average and maximum temperatures of the unexposed surface just before the moment of collapse (5 min 20 sec) were 147°F and 202°F respectively. The individual temperature was recorded by thermocouple number 14.

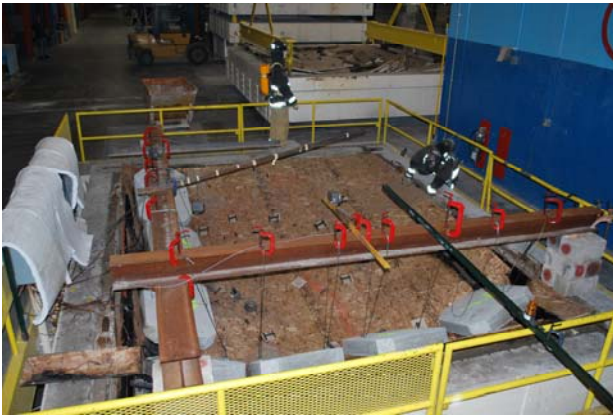
Figure 33. Unexposed side after collapse

sprinklers mounted around the assembly and manual hose streams. Once the fire was suppressed, pictures were taken to document the condition of the floor system on the exposed and unexposed sides (Figure 33 through Figure 36). The failure mode for the engineered wood and metal hybrid trusses was due to charring and subsequent release of the connections attaching the metal web to the wood chord member.

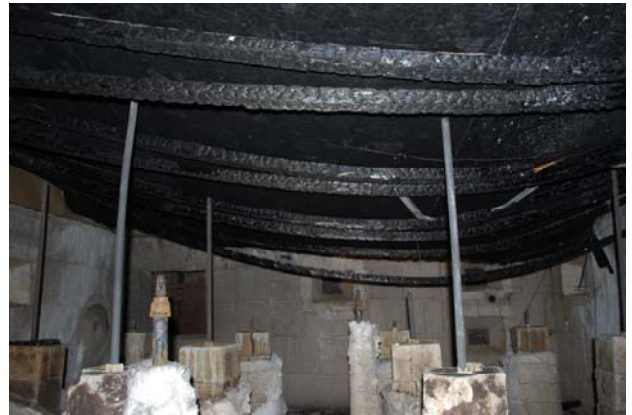
Figure 34. Exposed side from North end

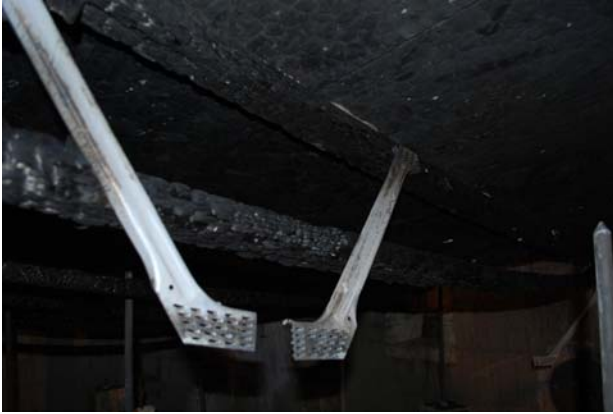
Figure 35. Joist with web disconnected

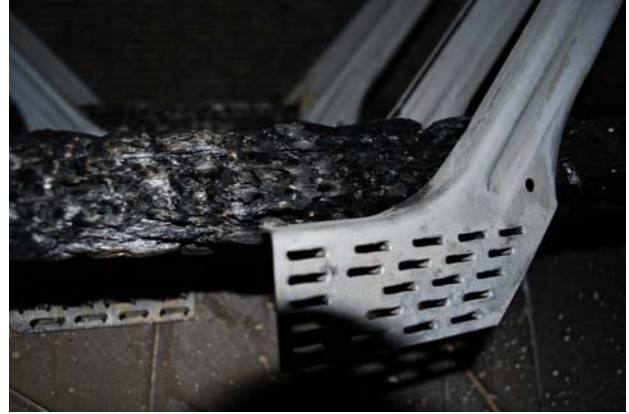
Figure 36. Close-up of char depth

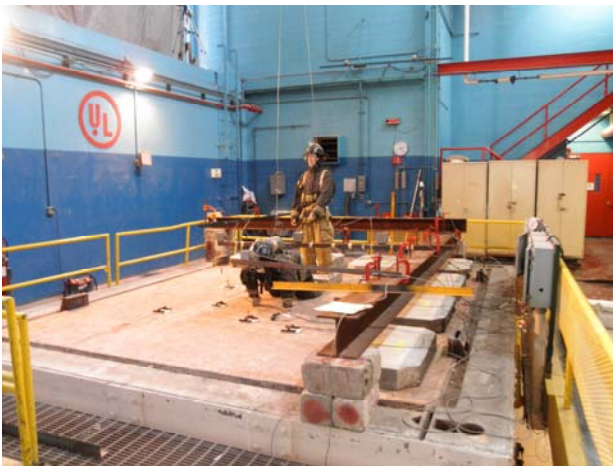
Figure 37. Pre-test un-exposed side

Experiment 1 examined an engineered I-joist floor assembly with a spray applied intumescent coating and the modified loading configuration (Figure 37 and Figure 38). The floor assembly failed at 17:50 after ignition. Observations made during the experiment of the exposed and unexposed sides of the floor assembly are detailed in Table 15. The average furnace temperature during the experiment began below the standard time temperature curve for approximately 2 minutes, but followed the curve closely for the duration of the experiment (Figure 39). The furnace pressure and oxygen concentration measured in the furnace are presented in Figure 40 and Figure 41 respectively. The pressure remained between -0.5 in. w.c. and 0.7 in. w.c. but fluctuated around 0 for most of the experiment. The oxygen concentration fluctuated and then decreased to less than 10 % by 8 minutes and remained at or below that concentration until collapse. Pressure and oxygen concentrations are not specified in the standard test method.

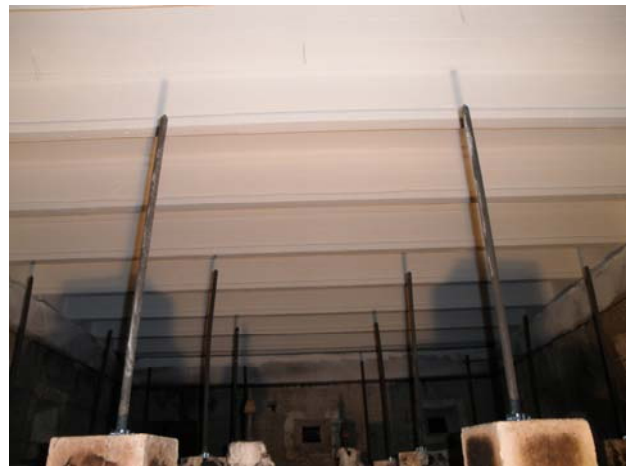
Figure 38. Pre-test exposed side

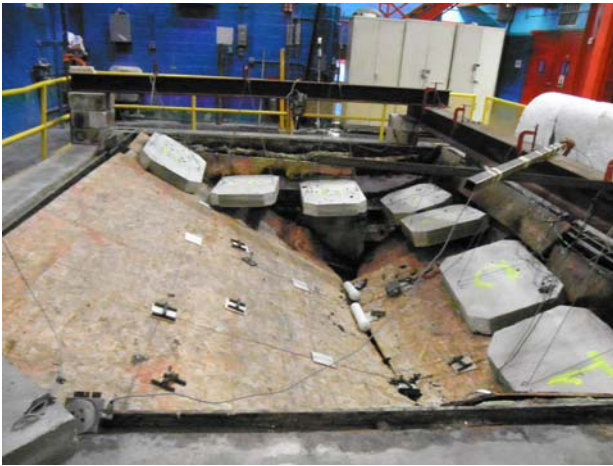
Figure 45. Unexposed side after collapse

suppressed utilizing sprinklers mounted around the assembly and manual hose streams. Once the fire was suppressed, pictures were taken to document the condition of the floor system on the exposed and unexposed sides (Figure 45 through Figure 48). The failure mode for the engineered I-joists with the intumescent coating was burn away of the joists at the bearing condition until the joists weakened under the load.

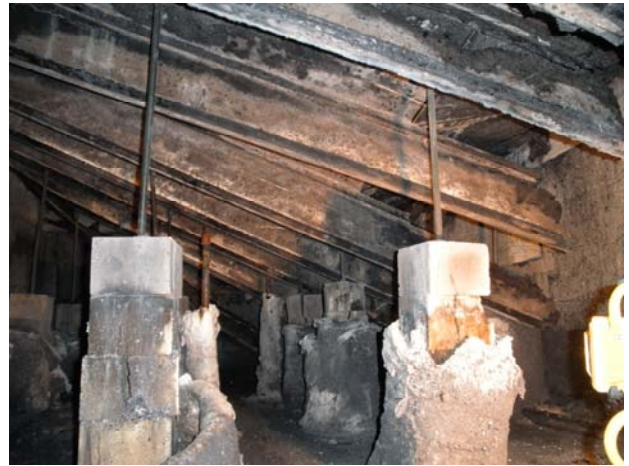
Figure 46. Exposed side from North end

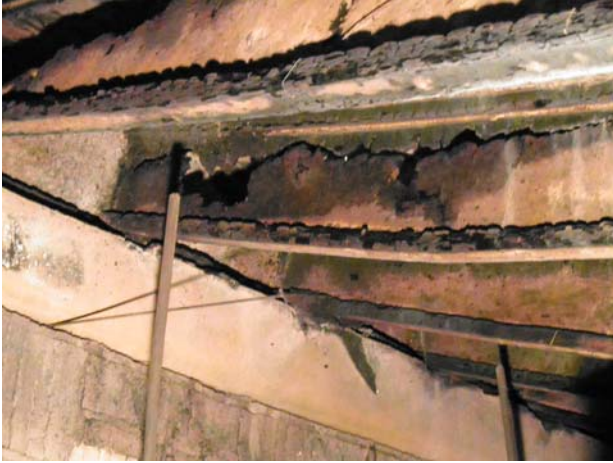
Figure 47. Joist with web burn through

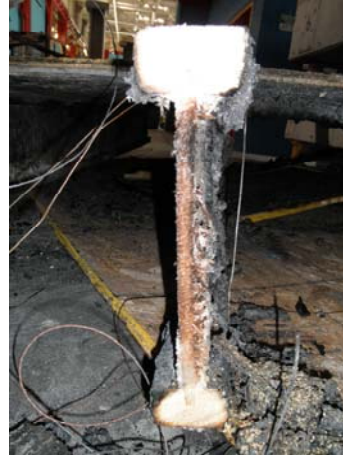
Figure 48. Close-up of remaining web

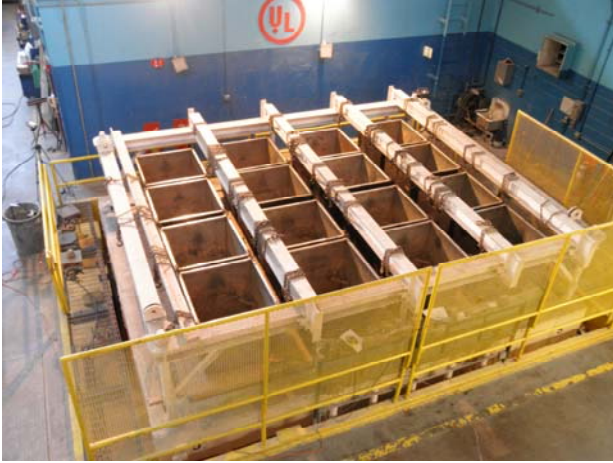
Figure 49. Pre-test un-exposed side

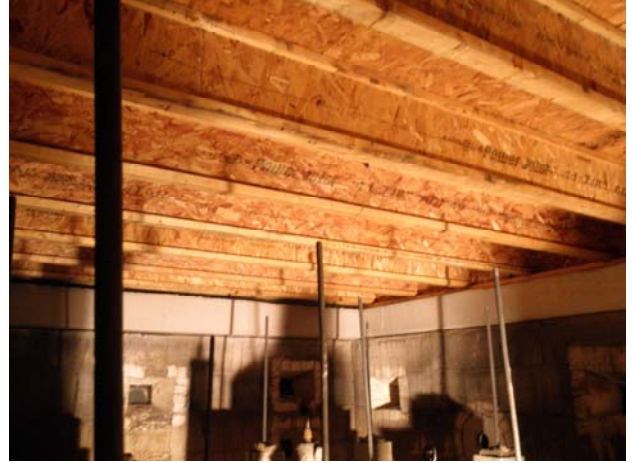
Figure 50. Pre-test exposed side

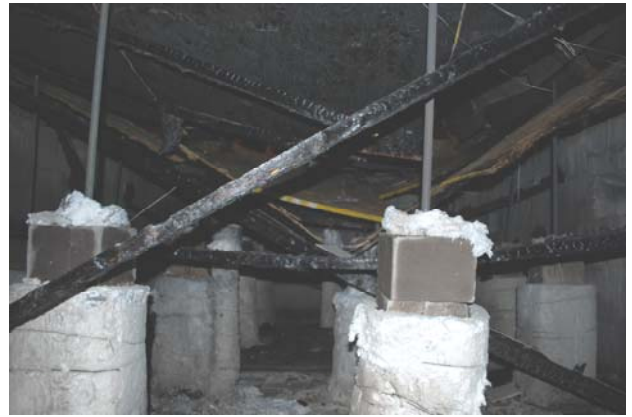
Figure 58. Exposed side from North end

document the condition of the floor system on the exposed and unexposed sides (Figure 57 through Figure 60). The failure mode for the engineered I-joists was thermal decomposition or consumption of the web member of the joists.

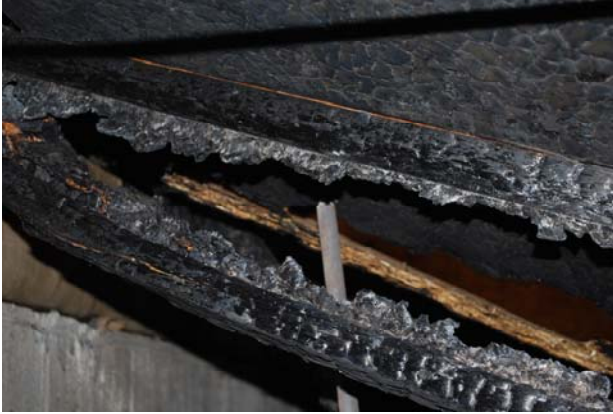
Figure 59. Joist with web burn through

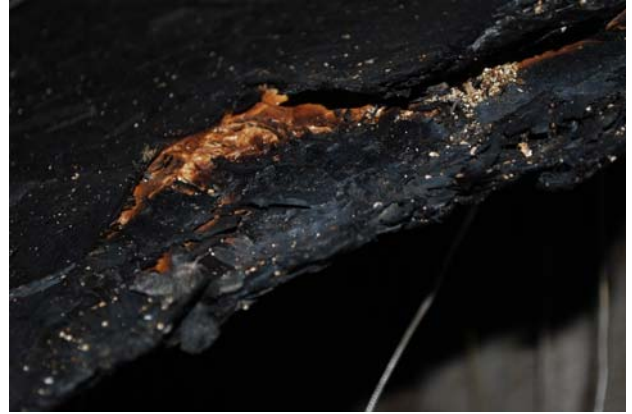
Figure 60. Close-up of some remaining web

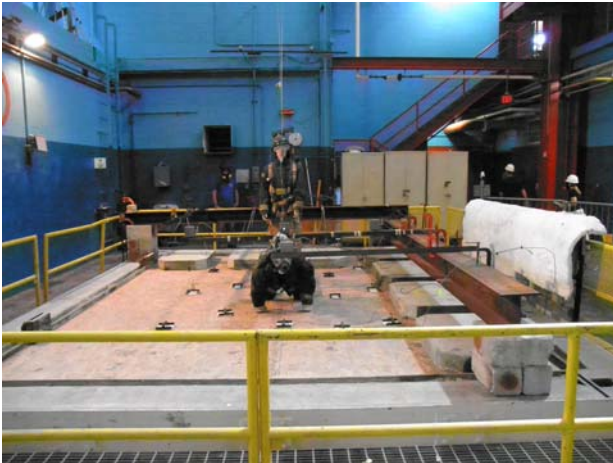
Figure 61. Pre-test un-exposed side

Experiment 5 examined an engineered I-joist floor assembly with a spray applied fire retardant coating and the modified loading configuration (Figure 61 and Figure 62). The floor assembly failed at 8:40 after ignition. Observations made during the experiment of the exposed and unexposed sides of the floor assembly are detailed in Table 17. The average furnace temperature during the experiment followed the standard curve closely until approximately 6 minutes when the floor system was involved in flames (Figure 63). The furnace pressure and oxygen concentration measured in the furnace are presented in Figure 64 and Figure 65 respectively. The pressure remained between -0.3 in. w.c. and 0.6 in. w.c. but fluctuated around 0 for most of the experiment. The oxygen concentration fluctuated and then decreased to less than 5 % by 7 minutes and remained at or below that concentration until collapse. Pressure and oxygen concentrations are not specified in the standard test method.

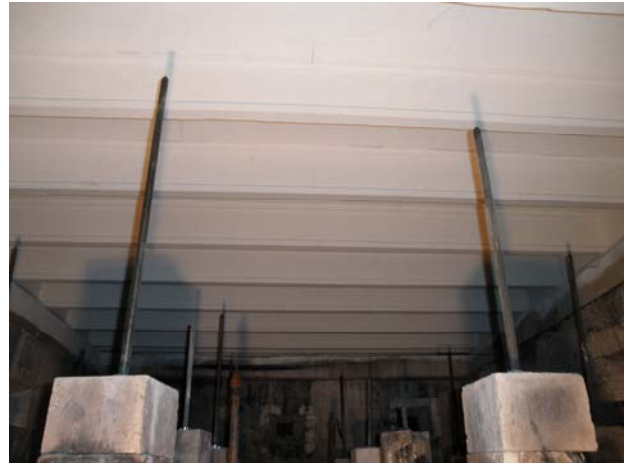
Figure 62. Pre-test exposed side

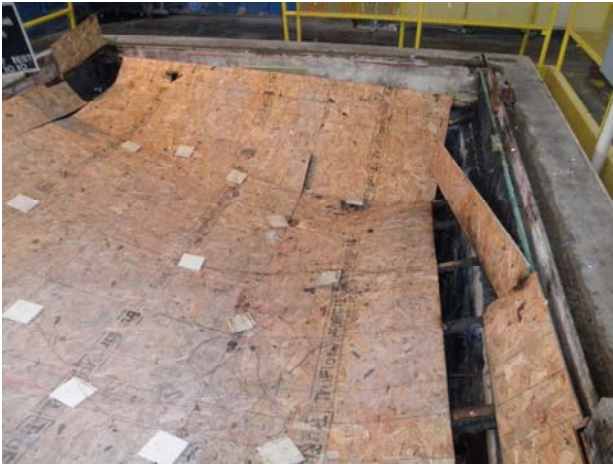
**Figure 69. Unexposed side after collapse**

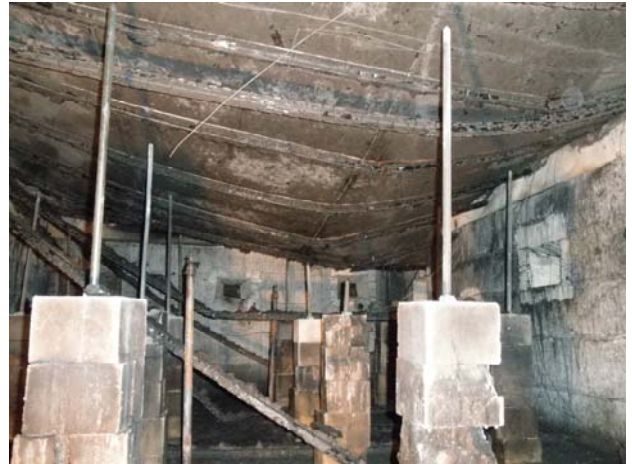
**Figure 70. Exposed side from North end**

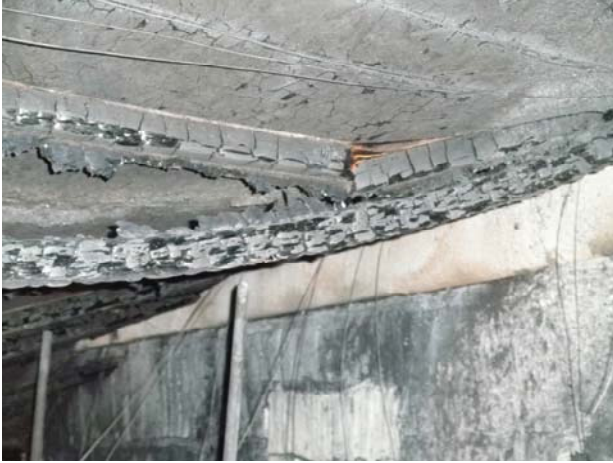
Figure 71. Joist with web burn through

The deflection of the floor-ceiling assembly during the fire experiment is shown on Figure 68. The location of each deflection transducer can be seen in Appendix A under Experiment Assembly 5. Measurable deflection began at approximately 4 minutes. A rapid deflection began at 7 minutes and continued until collapse. After the collapse of the floor system the fire was suppressed utilizing sprinklers mounted around the assembly and manual hose streams. Once the fire was suppressed, pictures were taken to document the condition of the floor system on the exposed and unexposed sides (Figure 69 through Figure 72). The failure mode for the engineered I-joists with the fire retardant coating was burn away of the web member of the joists.

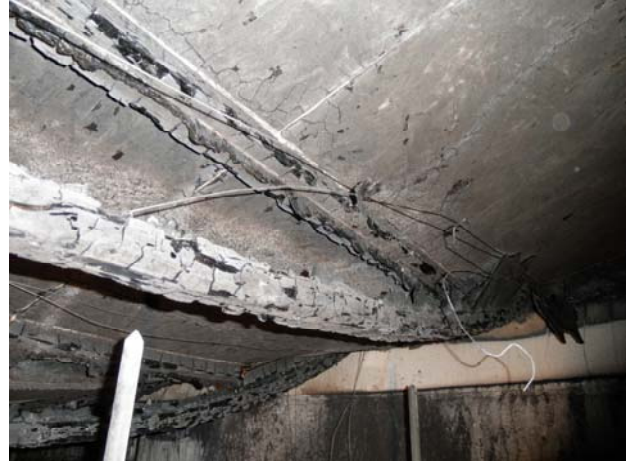
Figure 72. Close-up of some remaining web

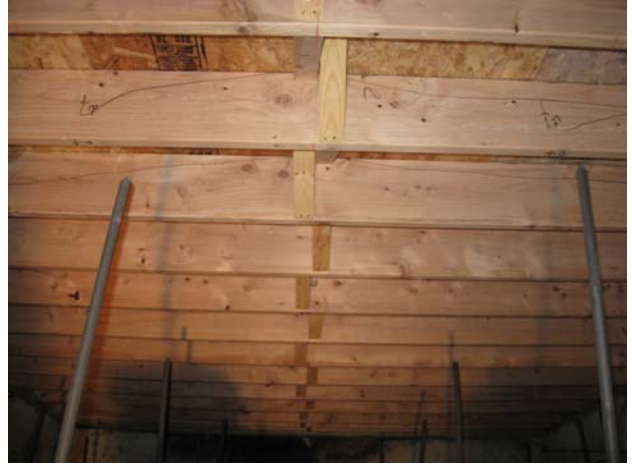
Figure 74. Pre-test exposed side

Experiment 6 examined a nominal 2 by 10 dimensional lumber floor assembly with the standard loading configuration (Figure 69 and Figure 70). The total design load for this floor system was calculated to be  $59.7 \text{ lb/ft}^2$ . The floor assembly failed at 7:00 after ignition. Observations made during the experiment of the exposed and unexposed sides of the floor assembly are detailed in Table 18.

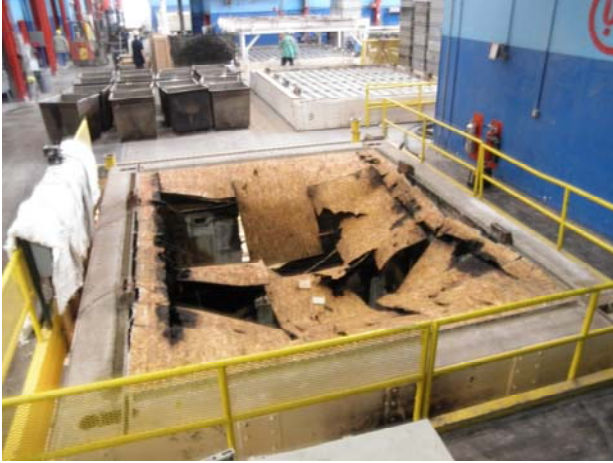
**Figure 81. Unexposed side after collapse**

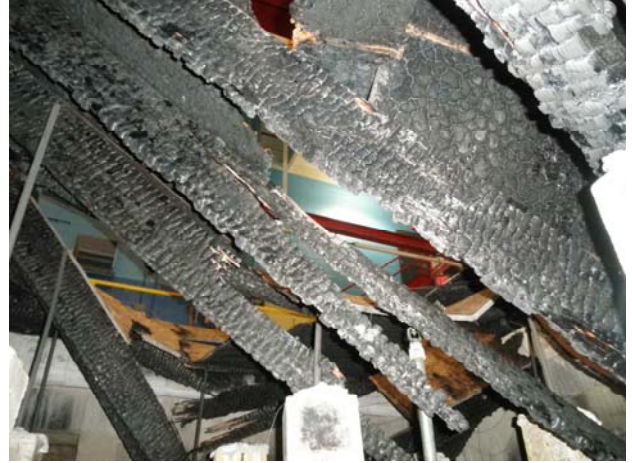
**Figure 82. Exposed side from North end**

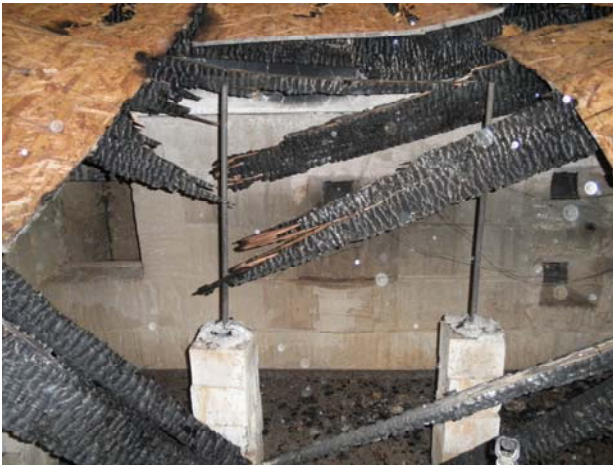
**Figure 83. Joist rupture in center span**

The deflection of the floor-ceiling assembly during the fire experiment is shown Figure 80. The location of each deflection transducer can be seen in Appendix A under Assembly 6. Measurable deflection began at approximately 45 seconds. Deflection steadily increased up until the time of collapse when readings ranged from 2.5 in. to 5 in. After the collapse of the floor system the fire was suppressed utilizing sprinklers mounted around the assembly and manual hose streams. Once the fire was suppressed, pictures were taken to document the condition of the floor system on the exposed and unexposed sides (Figure 81 through Figure 84). The failure mode for the traditional dimensional lumber joists was due to charring of the three fire-exposed sides of the joist which produced a reduction of the joist cross-sectional area. This area reduction, coupled with elevated temperature of the wood induced joist rupture.

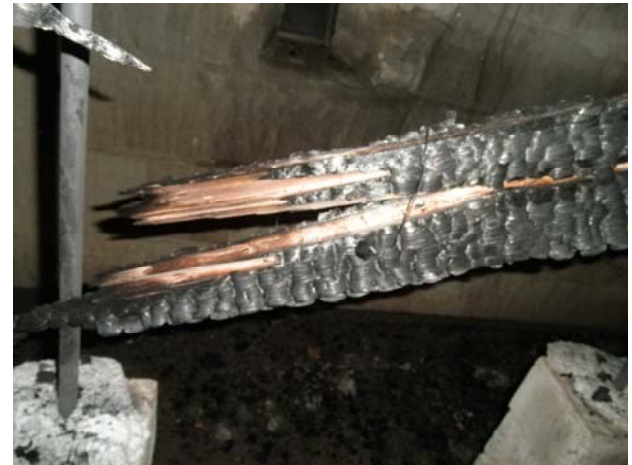
**Figure 84. Close-up of joist rupture**

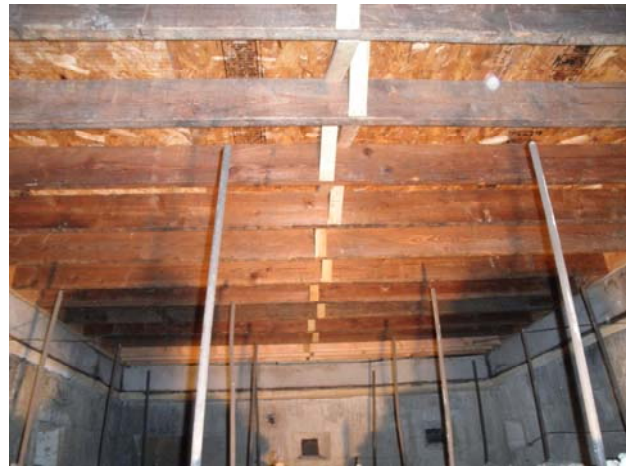
**Figure 86. Pre-test exposed side**

This experiment examined a nominal 2 by 8 dimensional lumber floor assembly with the standard loading configuration (Figure 85 and Figure 86). These joists were salvaged from a home that was being demolished. The home was built circa 1940 in Ohio. The total design load for this floor system was calculated to be 42.3 lb/ft<sup>2</sup>. Since the grade of the lumber was not known the calculation used the same details as the modern dimensional lumber experiment with the exception of the cross sectional area which was obviously different. The floor assembly failed at 18:05 after ignition. Observations made during the experiment of the exposed and unexposed sides of the floor assembly are detailed in

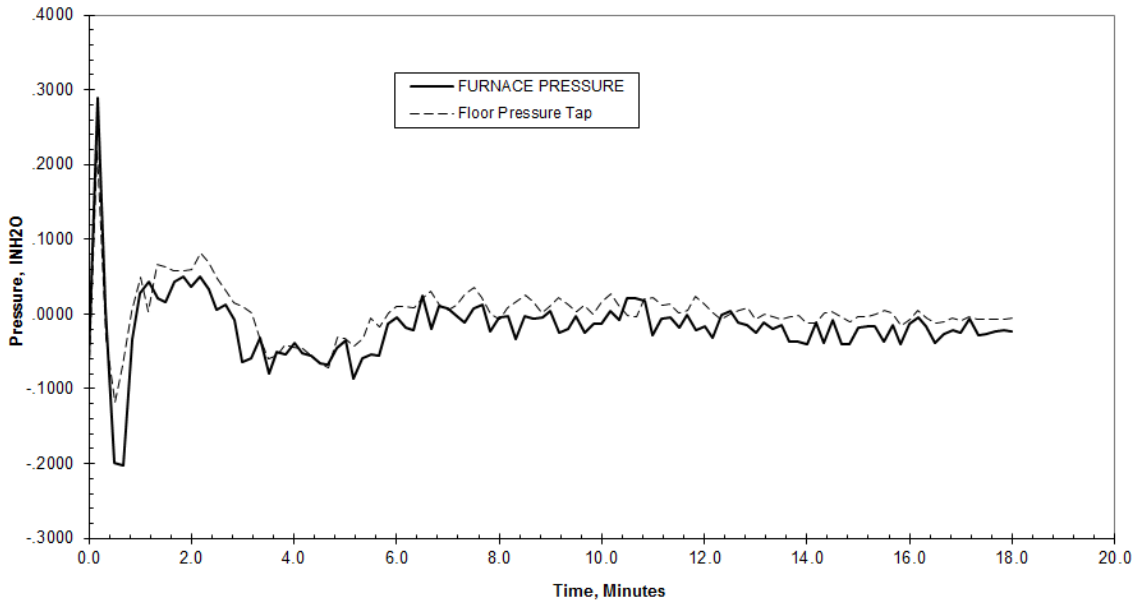
Figure 88 – Furnace Pressure vs. Time for Assembly No. 7

Table 19. The average furnace temperature during the experiment began below the standard time temperature curve but remained close to it for the duration of the experiment (Figure 87). The furnace pressure and oxygen concentration measured in the furnace are presented in Figure 88 and Figure 89 respectively. The pressure remained between -0.2 in. w.c. and 0.3 in. w.c. throughout the experiment. The oxygen concentration decreased to less than 2 % by 6 minutes and remained at or below that concentration until collapse.

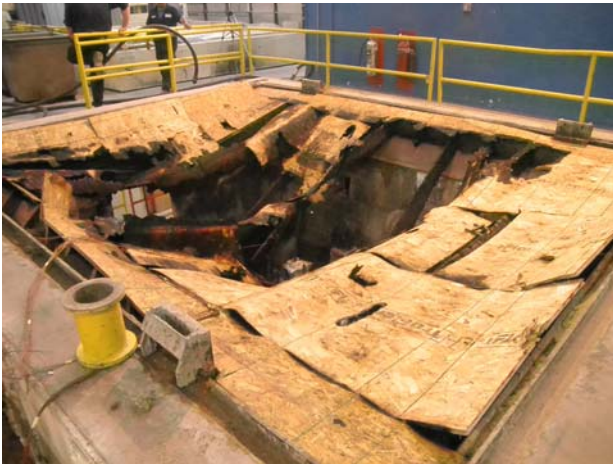
**Figure 93. Unexposed side after collapse**

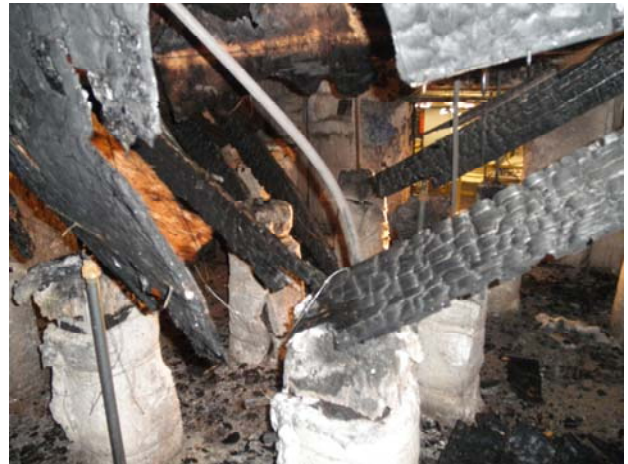
**Figure 94. Exposed side from North end**

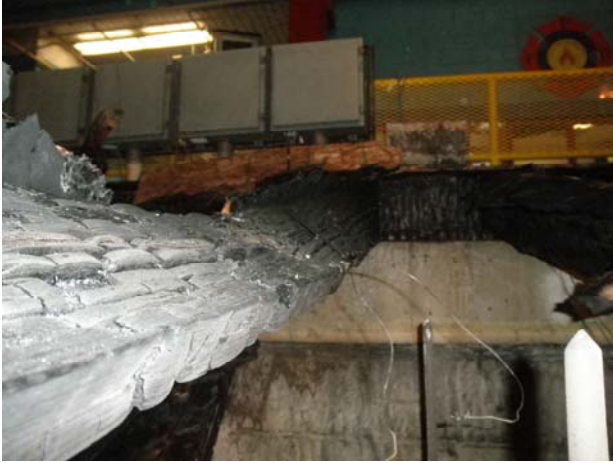
Figure 95. Joist rotation
