# Fire Service Collapse Hazard Floor Furnace Experiments

January 2012

## Executive Summary

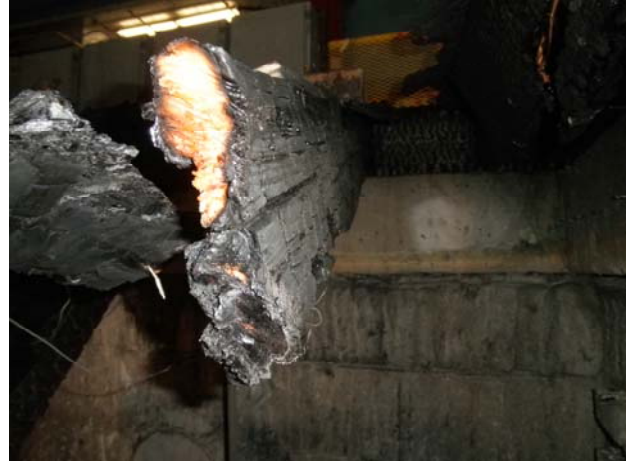
Figure 96. Close-up of joist rupture

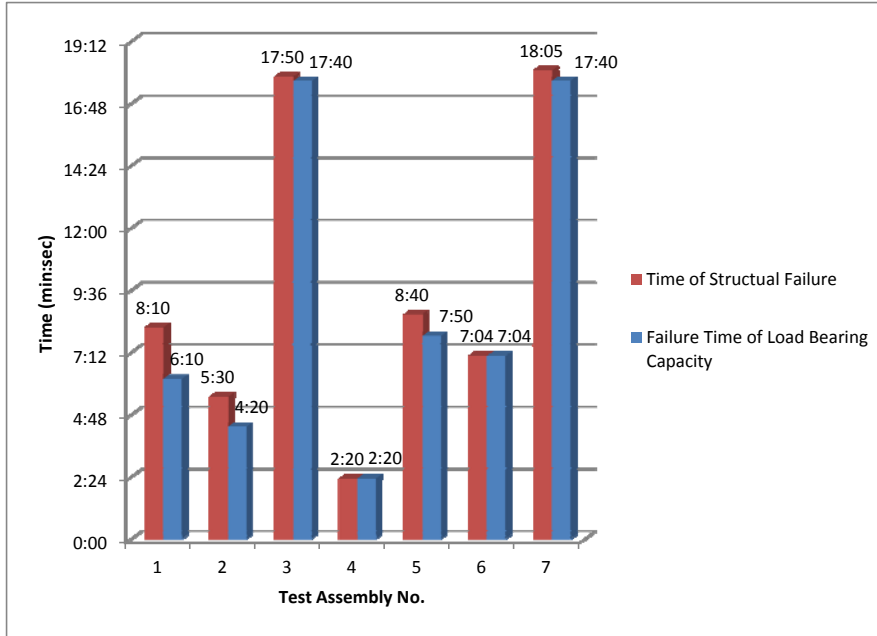
**Figure 97 - Summary of Time to Structural Failure and Failure of Load Bearing Capacity according to (ISO 834:1)**

A summary of the ISO 834:1 load bearing capacity and the structural failure of all five assemblies can be seen on Table 21 and Figure 97.

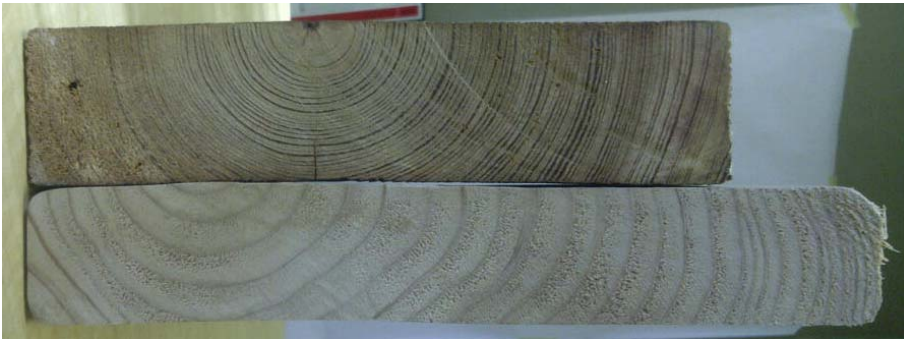
**Figure 99. Comparison of the modern 2 x10 to the old 2 x 8.**

The final dimensional lumber experiment was conducted with a smaller cross sectional area dimensional lumber floor that was comprised of wood reclaimed from a home built circa 1940 in Ohio. Even though the cross sectional area was smaller this floor system lasted 11 minutes longer than the modern dimensional lumber experiment with the same loading condition. Figure 99 shows a side by side comparison of the new and old lumber cross sections. The modern 2 x 10 had cross sectional dimensions of 1.5 in. by 9.125 in. and a density of 32.5 lb/ft<sup>3</sup>. The old 2 x 8 had cross sectional dimensions of 1.75 in. by

7.56 in. and a density of 36.9 lb/ft<sup>3</sup>. The modern 2 x 10 had an average moisture content of 15.75 % and the old 2 x 8 had an average moisture content of 9.0 %.

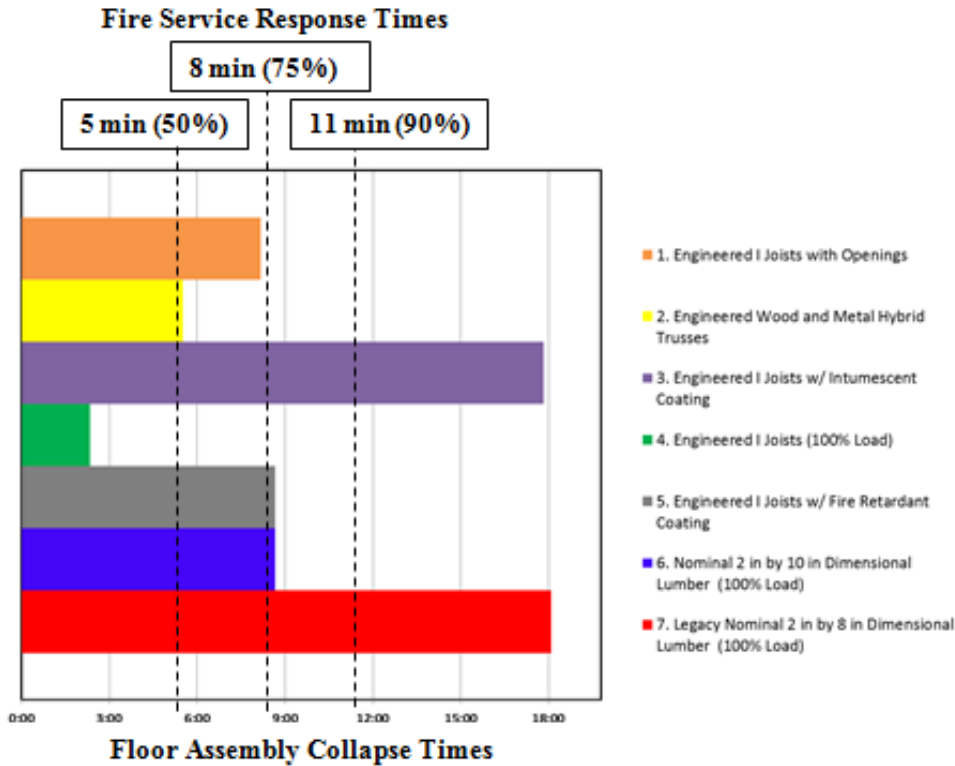
Figure 100. Fire service response times versus floor system collapse times

Figure 100 details the collapse times for each of the furnace experiments and overlays the national fire service response times. Even when assuming a witnesses ignition, immediate notification of the fire service and short response time there is not much time to operate safely before floor collapse regardless of the type of floor system. This emphasizes the importance of protecting all types of flooring systems, including dimensional lumber to increase the safe operational timeframe for the fire service.
